Quality control measurement of a MSS after 30 years of operation

An investigation into the effectiveness of one of the first mass-spring systems (MSS) in Switzerland is currently ongoing. After 30 years of operation, the vibration-reducing lightweight MSS is still performing without faults, despite the elastic bearing of the slab now being partially submerged in water. Vibration engineering experts **Adrian Egger** and **Markus Heim** provide further insight.

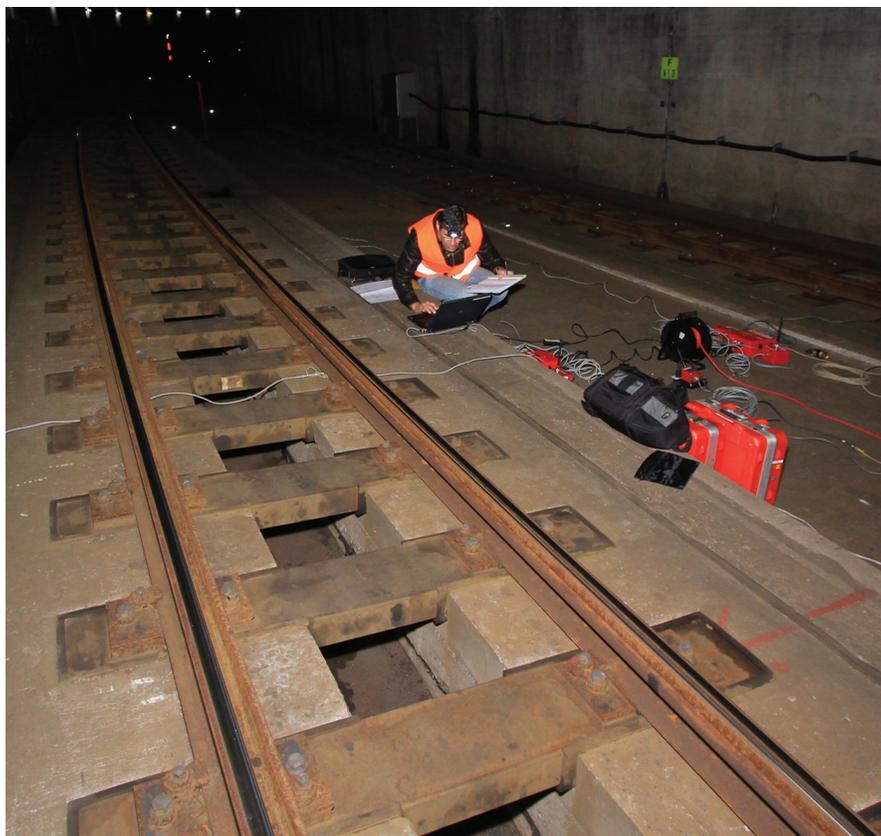
Measuring equipment in the measurement section with mass-spring system (MSS)

The vertical vibration velocities were measured at nine measuring points in the tunnel during a normal flow of traffic, both in the area equipped with the MSS and in an adjacent section of track not equipped with a vibration-reducing measure.

Measurements were taken at the same locations on the tunnel floor next to the tunnel wall in the MSS section as were used for the 1985 survey.

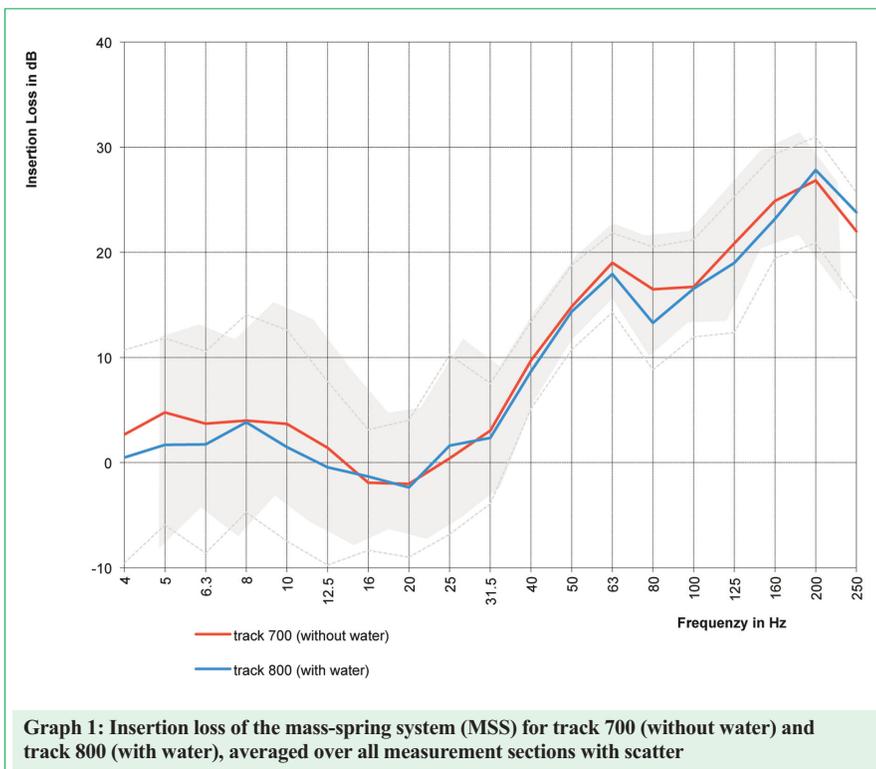
Graph 1: Insertion loss of the mass-spring system (MSS) for track 700 (without water) and track 800 (with water), averaged over all measurement sections with scatter

Graph 1 on page 60 shows the insertion loss with the corresponding scatter of the MSS for track 700 (without water) averaged over all passing trams, as well as the insertion loss of the MSS for track 800 (with water).

The investigation shows that the bearing of the Sylomer® material in water has no negative effect on the vibration reduction of the system.

The scatter for the insertion loss is the result of varying parameters, such as the recording of different tram types, rolling stock, speeds and various other factors that are difficult to record.

The slight difference between the insertion loss curves for both tracks can be attributed to influencing factors such as differing rail roughness, welded joints, etc.

The insertion loss determined for the MSS with Sylomer® in the tram tunnel in Schwamendingen, Zurich, shows an excellent insulation performance. The 30-year old MSS also conforms to the latest requirements and technological standards. The vibration insulation measure is in perfect working order. 🚄

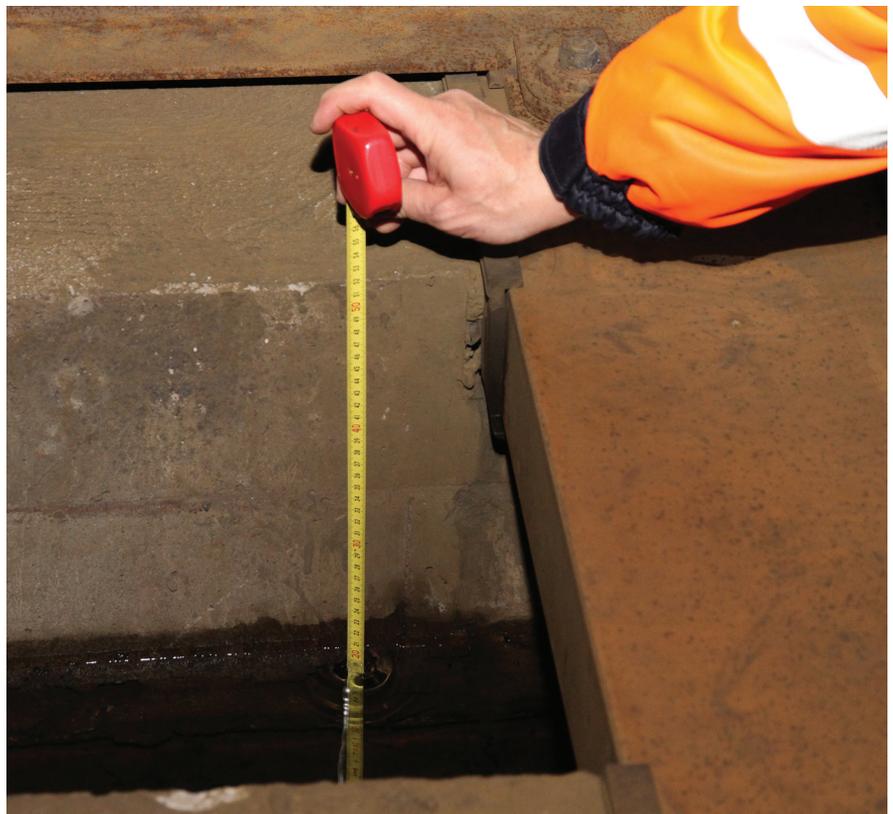
Standing water in the longitudinal groove of the mass-spring system (MSS) section, water level approximately 20cm

During an on-site inspection water was discovered in the longitudinal groove of the lower section track (track 800). The water level was up to 20cm-deep along most of the track area with MSS.

The water thus stands approximately 15cm above the level of the elastic bearing. There was no effective draining available for the section of track passing through the depression.
